ALASKA STYMIES STUDDED TIRES

by Tom Kuennen

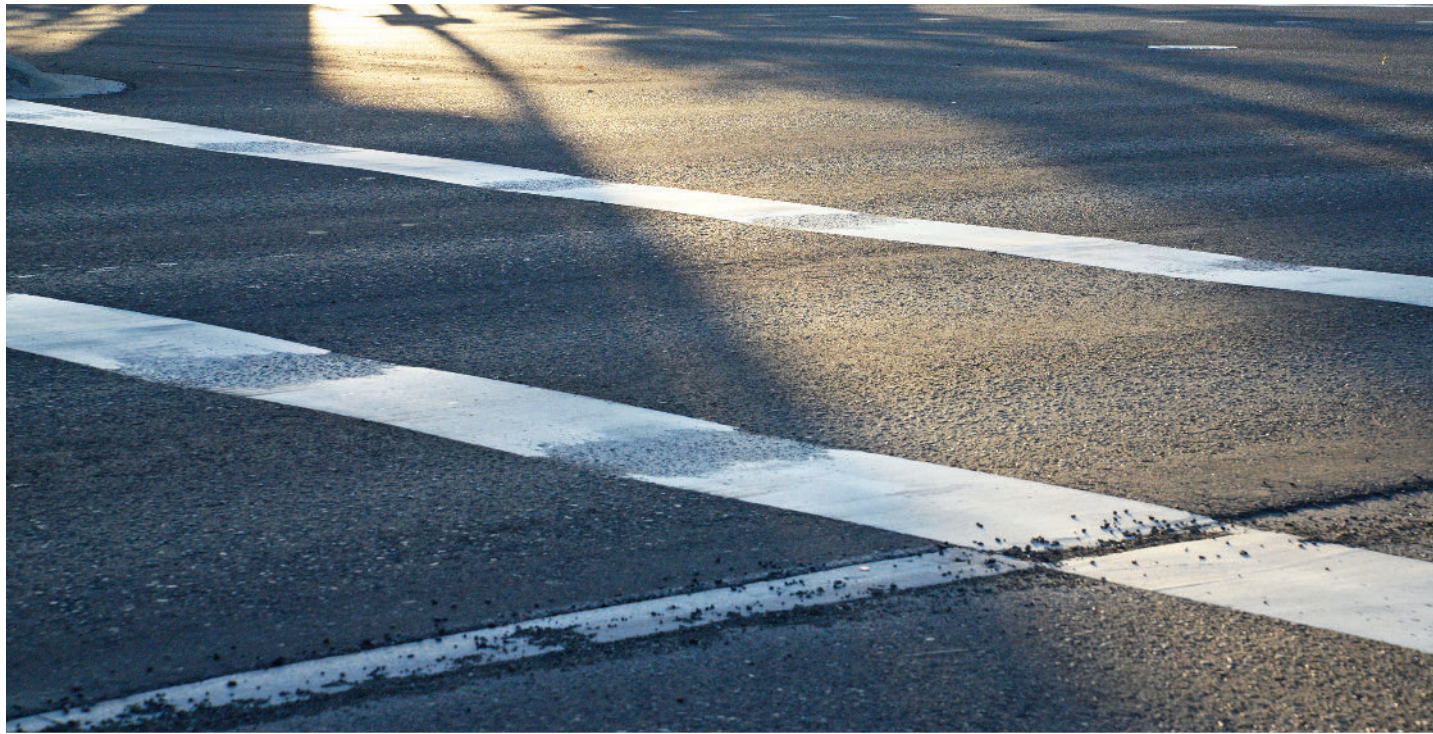
Undulating transverse shadows across rutted pavement -- and gouged intersection striping -- shows rut damage caused by studded tires on Minnesota Avenue in Anchorage

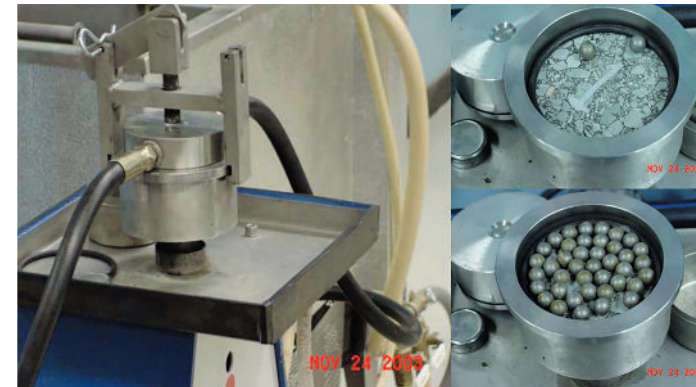
Alaska DOT&PF's Prall tester for studded tire damage

Lab tests confirm these performance properties, Kluttz says. The Prall test, Alaska Test Method 420, for studded tire damage was originally developed in the Nordic countries and is standardized as EN12697-16 in the European Committee for Standardization (hence the standard SI units). Test specimens are 100. mm (3.9 in.) in diameter and 30. mm (1.2 in.) thick and are tested at 5 °C (41 °F). The specimen is loaded in the test device and covered with 40 stainless steel spheres 12 mm (0.47 in.) in diameter. The test chamber is oscillated with a stroke of 43 mm (1.7 in.) at a frequency of 950 strikes per minute for a period of 15 minutes.

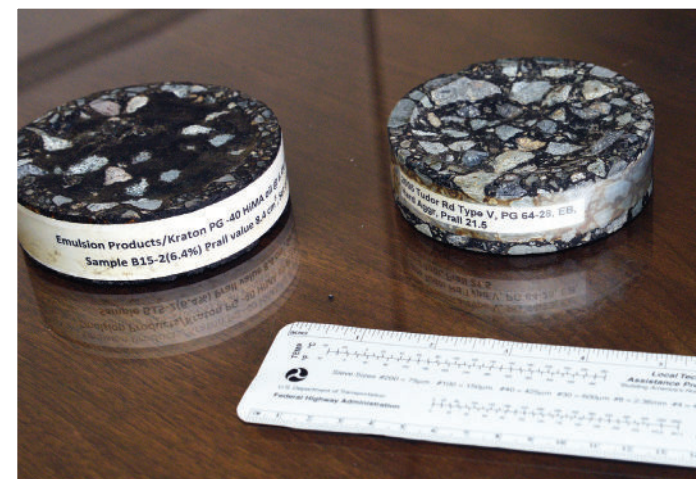
The standard Prall test specimen on the right shows typical abrasion with most of the aggregate clearly visible. The Prall test steel spheres progressively wear the binder and fine aggregate from the specimen surface. With the PG-40 HiMA binder specimen at left, much less of the surface is abraded due to its resilience, thus it can continue to protect the aggregate below from fracture

"What we saw with Prall testing was that the conventional material core sample has a lot of material removed," Kluttz says. "Large aggregate is pretty much all you see. The studs pick out small aggregate and binder, expose the large aggregate, and eventually that fractures and comes out. Then very quickly, the studs pick out more asphalt and fines in mastic."

"But with the HiMA sample, what you see is mostly asphalt," he says. "The test picked out some of the mastic and some of the large aggregate, but what remains is exposed asphalt that is just tougher. It's tough enough to resist being picked up by the studs."

The wheel paths look dark much like the Prall test specimens, indicating that roughly the same behavior is occurring in the laboratory and in the field. The Alaska DOT&PF is pleased with the performance and is specifying more projects with modified PG 64-40 E binder and hard aggregates, designated as Hot Mix Asphalt, Type VH by Alaska DOT&PF.

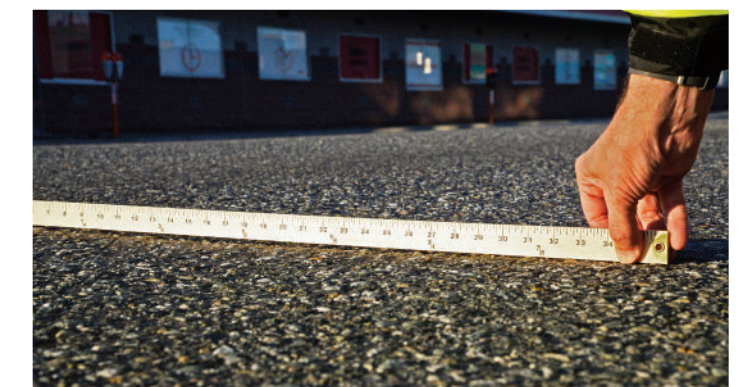
After four winter seasons (2015-2019), 200 block of E 5th Avenue with HiMA-modified PG 64-40 E binder shows minimal rutting

To date, performance has been good with minimal damage caused by studded tire wear or traffic loads. In 2019, after four years of traffic including studded tires, the average rut depths were 0.204 in. (5.2 mm) on 5th Avenue and 0.198 in. (5.0 mm) on 6th Avenue in downtown Anchorage.

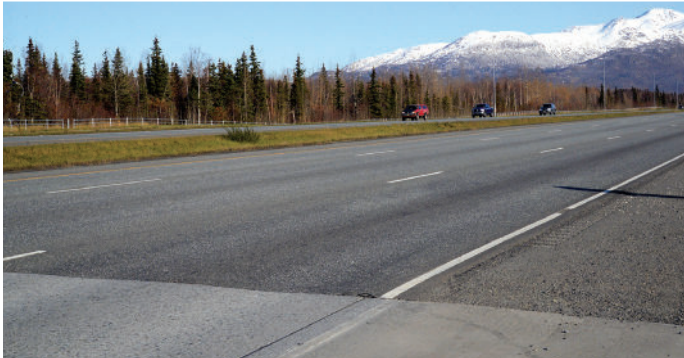
HiMA mix, eastbound Glenn Highway Alaska S.R. 1 at weigh station near Eagle River shows minimal studded tire rutting after two years

In 2017, the rubberized mix was milled and replaced with 2 in. (5 cm) of Hot Mix Asphalt, Type VH for resurfacing 15.2 miles (24.5 km) of Glenn Highway. Some 50,000 tons (45,000 mt) of Hot Mix Asphalt with PG 64-40 E HiMA binder and hard aggregate were placed. In 2019, the average wear on this Superpave mix between Airport Heights and Hiland roads was just 0.21 in. (5.3 mm) versus 0.32 in. (8.1 mm) of crumb rubber asphalt, both after two years of service.
